### Site 329 Rings Island – Ferry Road

Great Marsh Coastal Wetlands Restoration Plan  
Rapid Technical Assessment Site 329

## Rapid Field Assessment

Rings Island - Ferry Road

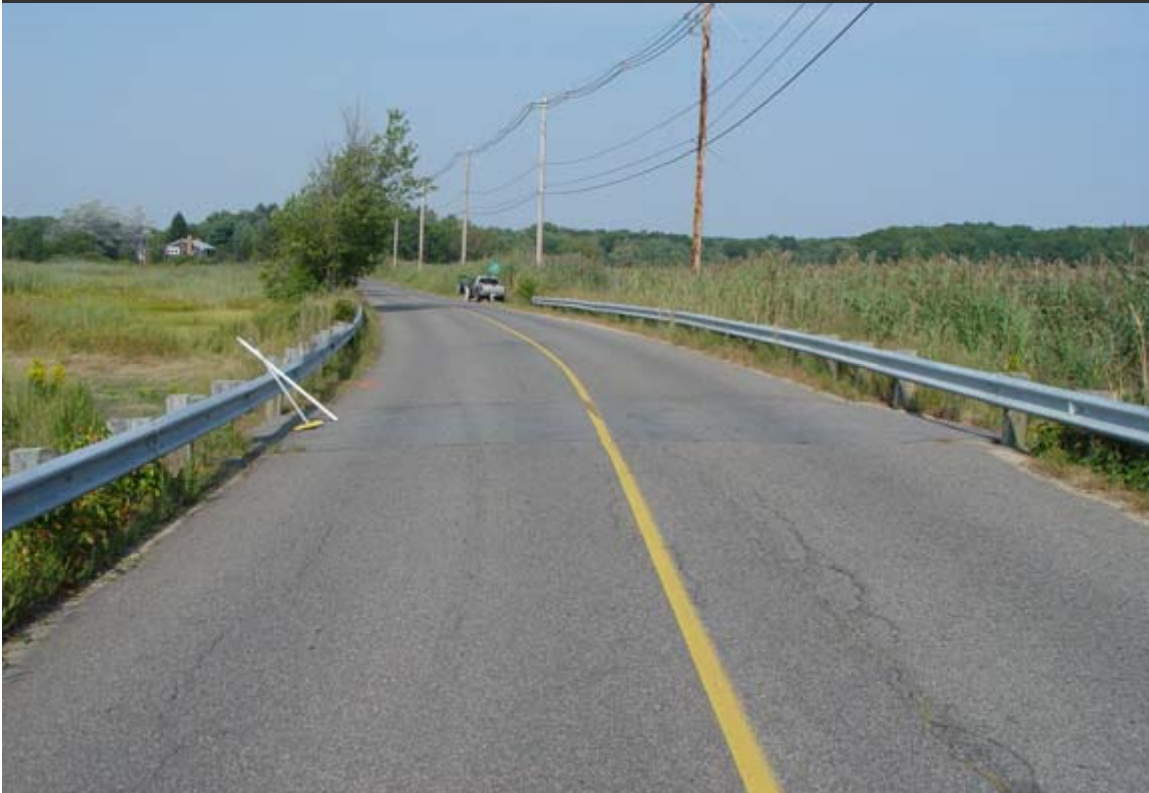
**Structure conditions:** Tidal flow is conveyed under Ferry Road via a 2.3 ft wide by 3 ft high granite block culvert. The culvert shows some signs of seepage and erosion around the upstream and downstream inverts, but the granite blocks appear to be stable. Riprap protects the upstream and downstream inverts of the culverts from erosion and scour. Stones surrounding the inlet and outlet form a cut stone headwall. There were indications that the pavement around the culvert has been recently repaired. This is typically an indication of settlement or loss of material around the culvert through infiltration. The overall culvert is in fair condition. The creek banks upstream and downstream of the culverts are severely eroded and subsequently have large scour pools. This is most likely a result of high velocities through the culvert and the culvert's poor alignment with the creek.

**Photo 2 - Upstream View of Culvert Crossing**

To increase tidal flow, the existing stone box culvert will have to be replaced with a larger box culvert set lower in the creek channel. The new culvert should also be placed to the north to be better aligned with the creek. This would allow the existing structure to remain in place during construction and avoid the need to construct a temporary bypass. For initial cost estimates we assumed an 8 ft high by 10 ft wide concrete box culvert. A larger structure may be possible pending further modeling and investigations of low-lying abutters. Construction costs associated with replacing the culvert are estimated to be in the range of \$550,000. This effort also assumed some additional work within the upper reaches of the marsh to improve tidal circulation and draining of accumulated fresh water. Additional work within the Rings Island Marsh to improve hydraulic connections to the adjacent potential restoration site is discussed under Site 328.

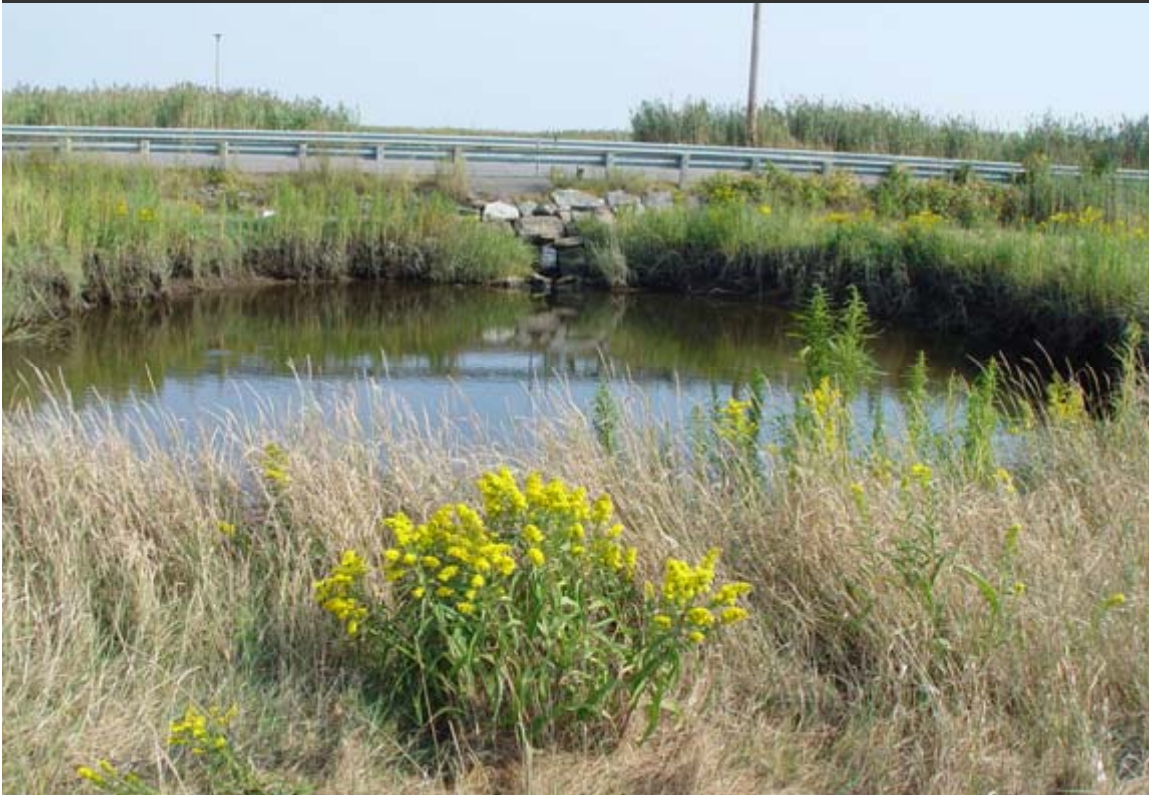
**Photo 3 - Downstream View of Culvert Crossing**

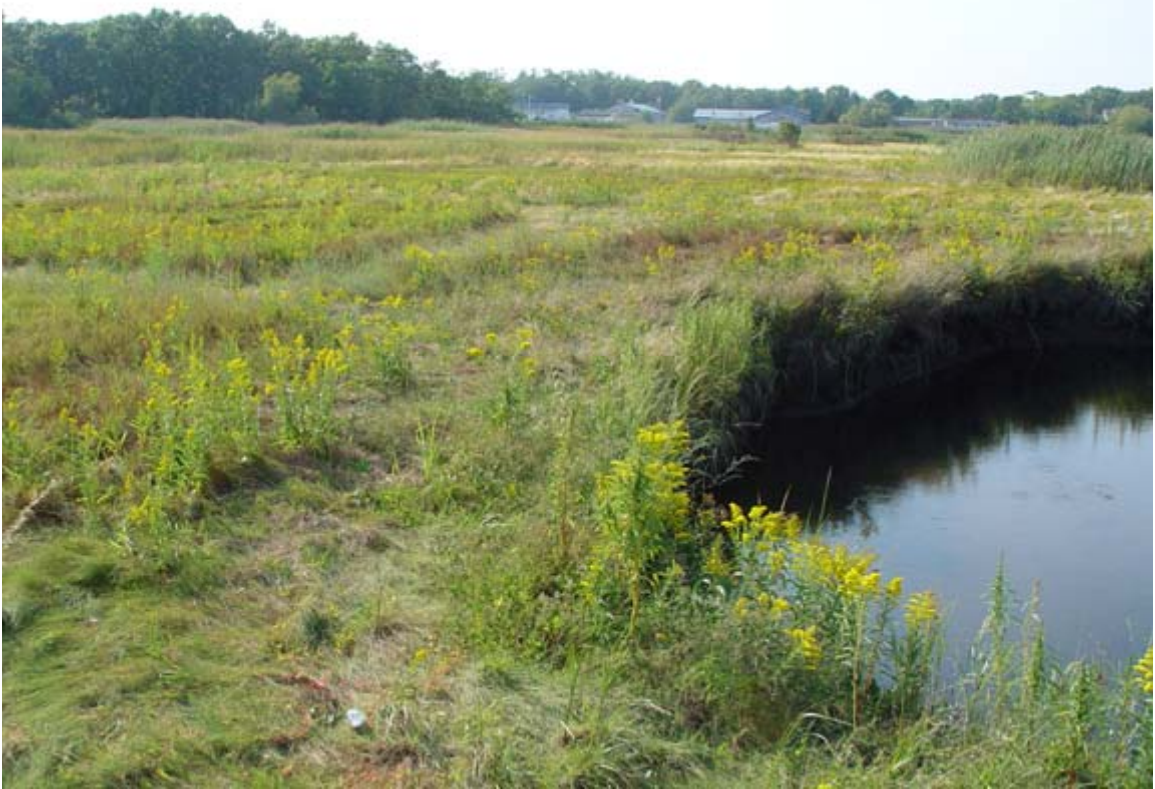
# Site 329: Rings Island, Ferry Rd., Salisbury, MA

Two tide gauges were deployed from May 18 to June 3, 2005 upstream and downstream of the culvert under Ferry Road. Results of the gauge deployment show a significant restriction of tidal flow through the culvert which increases with tidal prism. These restrictions occurred during all of the 29 tidal cycles recorded for this deployment. Tidal restrictions ranged from 0.88-3.28 ft and delays ranged from 16 min to 2 hr 6 min. The highest recorded tide downstream of the culvert occurred during a major coastal storm on May 26 at 2:00 AM at an NGVD adjusted height of 8.87 ft. Upstream high tide occurred at 4:06 AM at an adjusted height of 5.76 ft. During the peak of the tidal cycle, the roadway system was overtopped causing a pronounced delay in the ebb tide upstream of Ferry Road. The resulting tidal dampening was 3.11 ft. and a delay of 2 hr 6 minutes. The dampening amounted to approximately 33.1% of the total tidal prism recorded at the downstream gauge. The only larger restriction recorded was 3.28 ft on May 25 during the morning tide. This restriction amounted to 35.1% of the total tidal prism recorded at the downstream gauge. The dampening effect provided some flood protection to relatively low-lying properties along Route 1 and north of the crossing along Ferry Road. The tidal restriction during more typical spring tide conditions (similar to the tide which reached elevation 5.5 ft on May 22<sup>nd</sup>) is approximately 0.9 ft.
